**NASA TECHNICAL NOTE**

**NASA TN D-8411**

**EFFECT OF LOW-VELOCITY IMPACT DAMAGE  
ON THE COMPRESSIVE STRENGTH OF  
GRAPHITE-EPOXY HAT-STIFFENED PANELS**

*Marvin D. Rhodes, Jerry G. Williams,  
and James H. Starnes, Jr.*

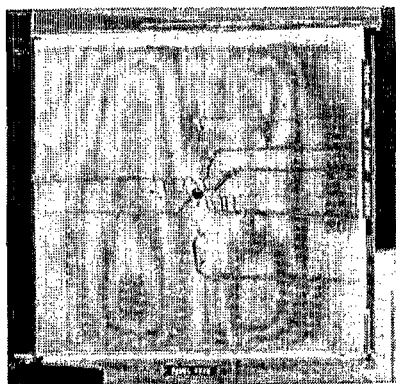
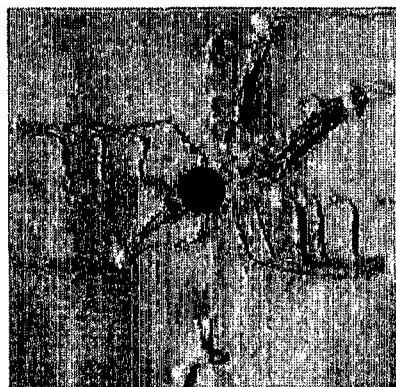
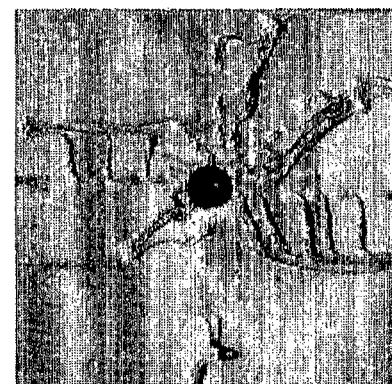
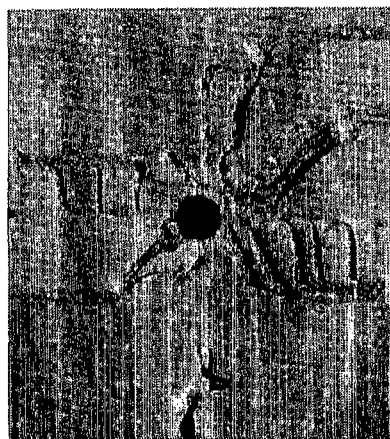
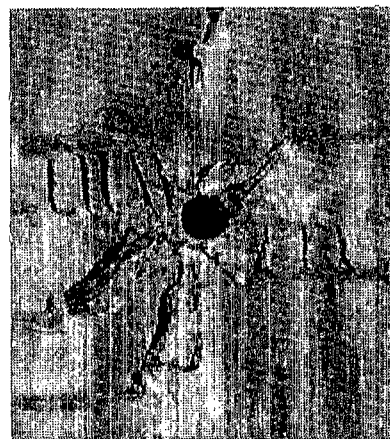
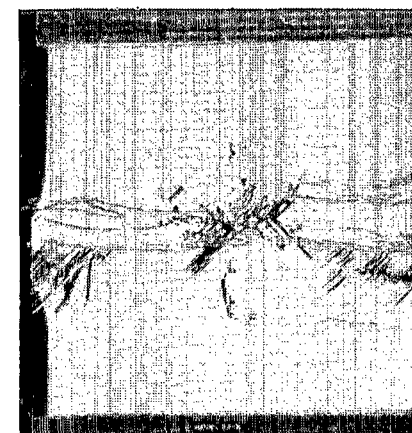
Figure 6.- Photographs of moiré-fringe patterns of panel B5 at several values of applied axial strain  $\epsilon_a$ .

At applied strains near 0.0049 large changes in strain were recorded near the cutout and noticeable panel displacements began to develop in the vicinity of the cutout. Moiré-fringe patterns representing the normal displacement field near the cutout are shown in figure 6 for several values of applied strain. A representative moiré-fringe pattern for an applied strain of 0.0048 is shown in figure 6(a) and a closeup of the cutout region for this applied strain is shown in figure 6(b). At an applied strain of approximately 0.0049 a local buckling displacement field began to develop at the cutout edge about 60° counterclockwise from the loading axis. This displacement field was about 1.0 cm long for an applied strain of 0.0050 and is shown in figure 6(c). As the applied strain was increased, the extent of the displacement field increased to a length of about 1.8 cm for an applied strain of 0.0055 as shown in figure 6(d). At an applied strain of 0.0057, the displacement field had rotated counterclockwise to a position 90° from the loading axis (fig. 6(e)) and extended on both sides of the cutout. This displacement field extended about 2.5 cm on the left side and about 2.4 cm on the right side of the cutout which makes the total length of this displacement field approximately equal to the width of the 0° fibers in the skin under the stiffener. The local displacement field propagated across the panel (fig. 6(f)) at an applied strain of 0.0058 which indicates that the local behavior precipitated panel failure.

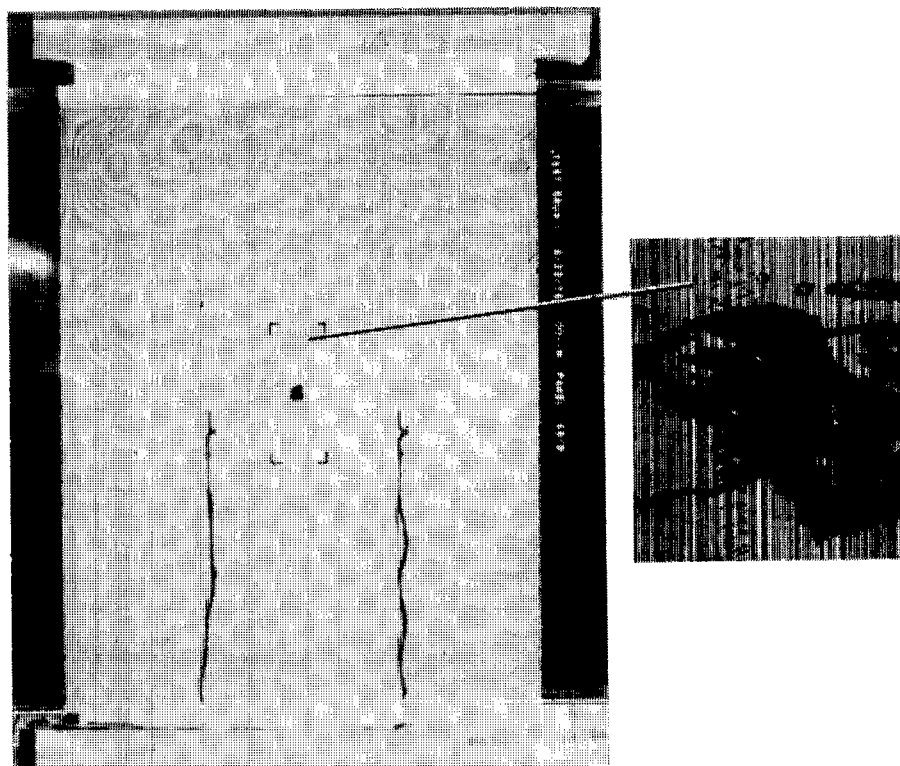
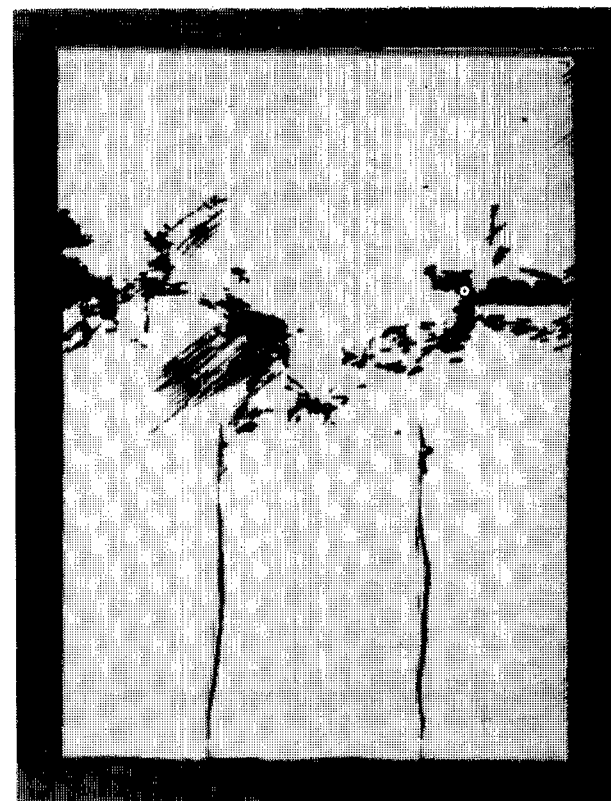
Figure 7.- Panel A4 (after impact in high-axial-stiffness region while at zero applied axial strain) before and after failure.

Photographs of the moiré-fringe pattern of panel A4 loaded prior to failure and of the failed panel are shown in figure 7. The moiré-fringe pattern (fig. 7(a)) is similar to that of the undamaged panel A1 (fig. 3(a)). The dark

spot in the center of the panel is the impact location where the paint has been removed for post impact inspection. Figure 7(b) indicates that the panel failure region is extensive and includes the impact location. The panel was inspected ultrasonically prior to failure, and a photograph of the oscilloscope record for the region in the vicinity of the impact location is shown in the insert of figure 7(a). The area represented by the insert is outlined on the photograph. The dark area shown in the insert indicates subsurface damage in the panel. This area is about 6.35 cm long and about as wide as the region beneath the hat which contains 0° plies. The results of tests on panels A4 and A5 were similar and both panels failed at applied strains near their design strain level (0.0034).

(a) Photograph of moiré-fringe pattern of buckled panel at applied axial strain of 0.0035. Insert shows region of subsurface damage.

(b) Panel after failure.

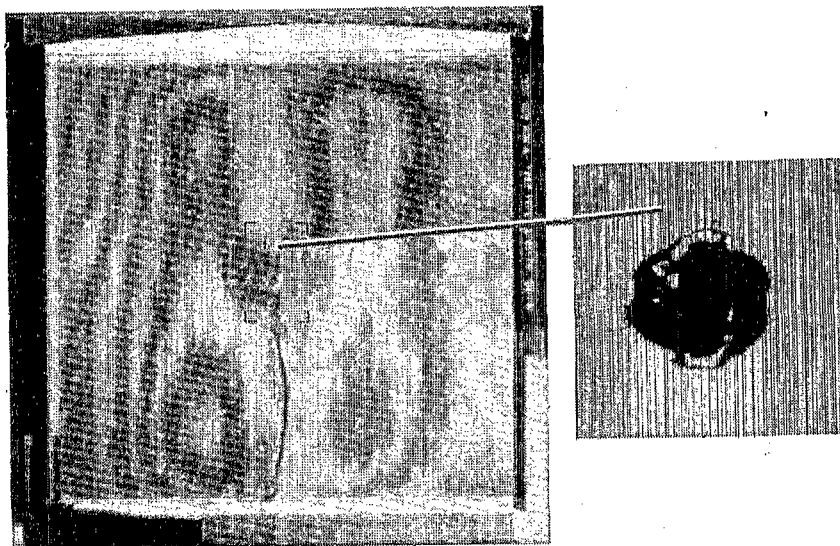
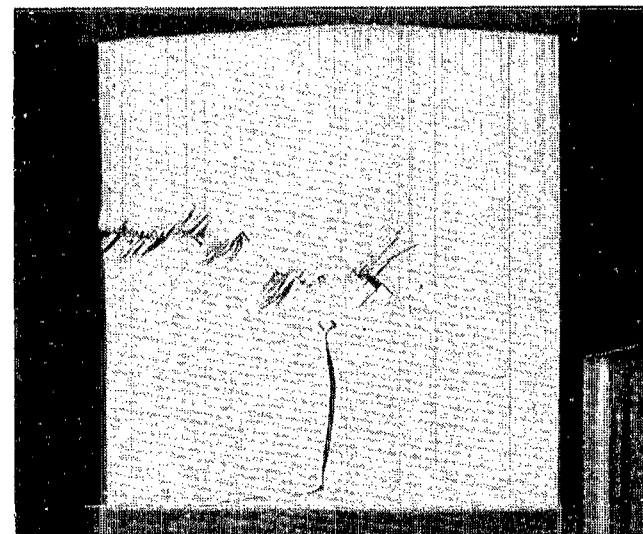
Figure 8.- Panel B6 (after impact in high-axial-stiffness region while at applied strain of 0.0003) before and after failure.

Photographs of the moiré-fringe pattern prior to failure and of the failed panel B6 are shown in figure 8. A small circular pattern in the region of impact was observed with the moiré-fringe technique indicating the presence of local damage. The development of this fringe pattern and an examination of the panel failure indicate that the impact damage precipitated the panel failure. Failure occurred at an applied strain of 0.0043 which is about 54 percent of the design value.

(a) Photograph of moiré-fringe pattern at applied axial strain of 0.0041 showing development of fringe pattern near point of impact. Insert shows region typical of subsurface damage in similar test panel.

(b) Panel after failure.

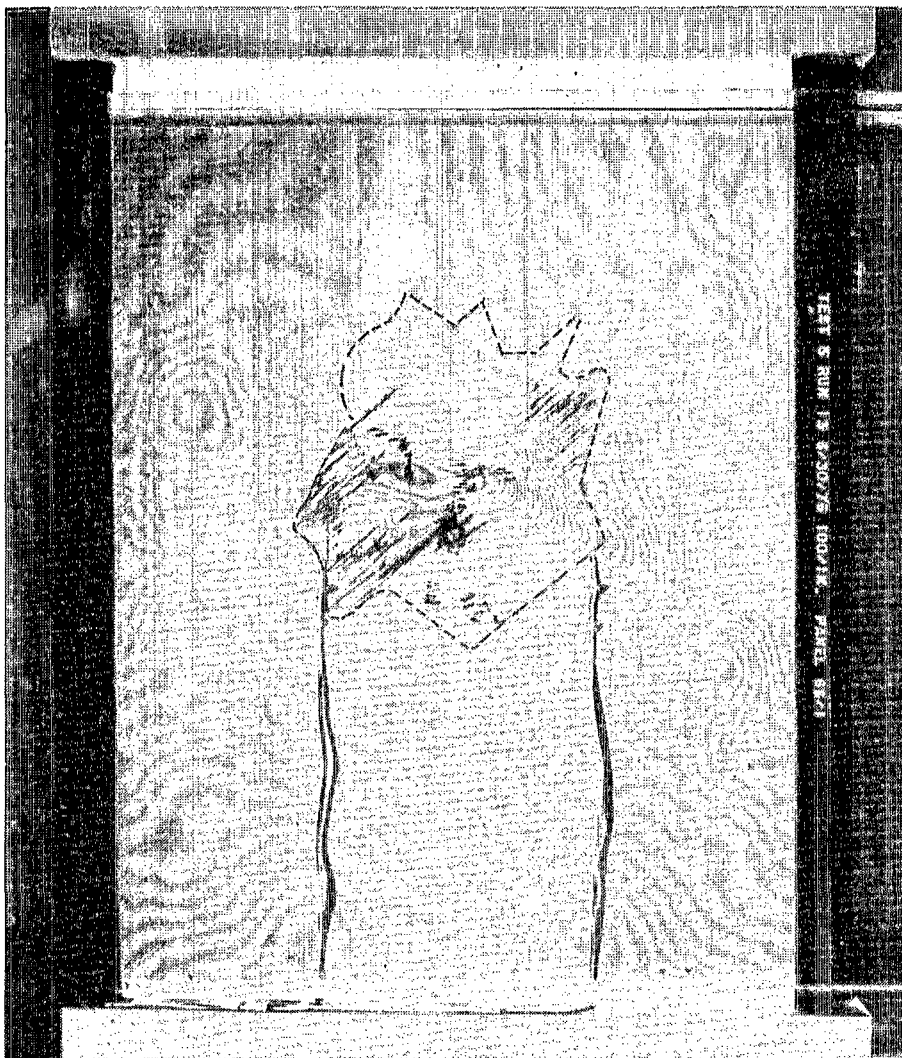
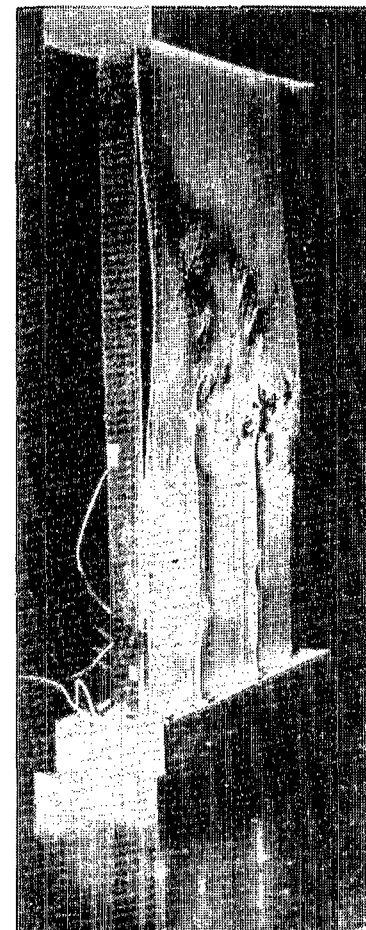
Figure 10.- Panel A3 (after impact in high-axial-stiffness region while at applied strain of 0.0034) before and after failure.

High axial strain at impact: Test panels A3, B7, and B8 were damaged by impact with a high axial load applied. (See table II.) Panels A3 and B7 which had an applied axial strain of 0.0034 and 0.0030, respectively, had a large region of visually detectable damage in the impact area. Instrumentation monitoring applied load indicated both panels had significant load reductions at impact due to loss in panel stiffness (table II). Both were subsequently loaded to failure to determine the panel residual strength. Panel A3 was ultrasonically inspected prior to the residual strength test and an extensive region of subsurface damage was detected. A photograph of the moiré-fringe pattern of the panel loaded prior to failure is shown in figure 10(a) where the subsurface-damage region is outlined. Even though the damage in panel A3 is extensive, it buckled at an applied strain near the design level and carried additional load after buckling similar to the undamaged panels. The panel failed in the region of the impact damage (fig. 10(b)) at an applied strain of 0.0037. Comparison of panel A3 with panels A4 and A5, all of which were designed for a load of 0.53 MN/m at an axial strain of 0.0034, indicates that

the extent of the subsurface damage did not significantly affect the strain level at which the panels failed.

(a) Photograph of moiré-fringe pattern of buckled panel at applied axial strain of 0.0031.

(b) Panel after failure.

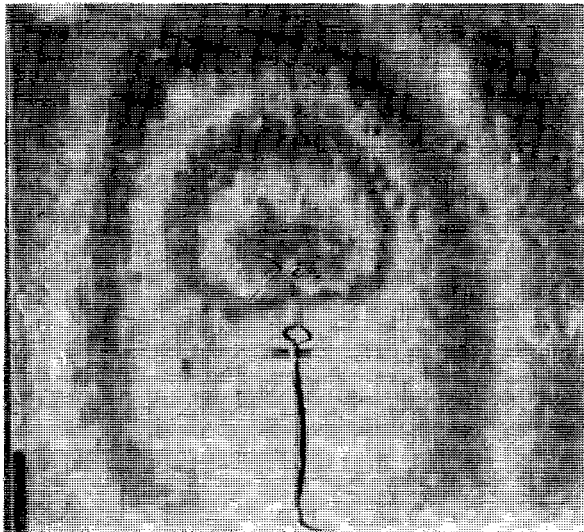
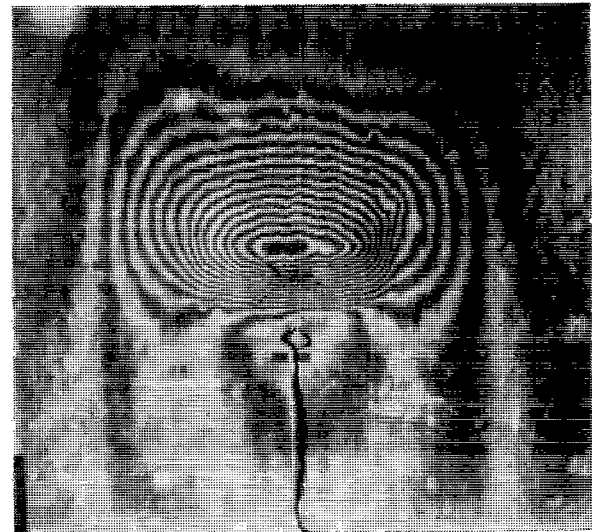
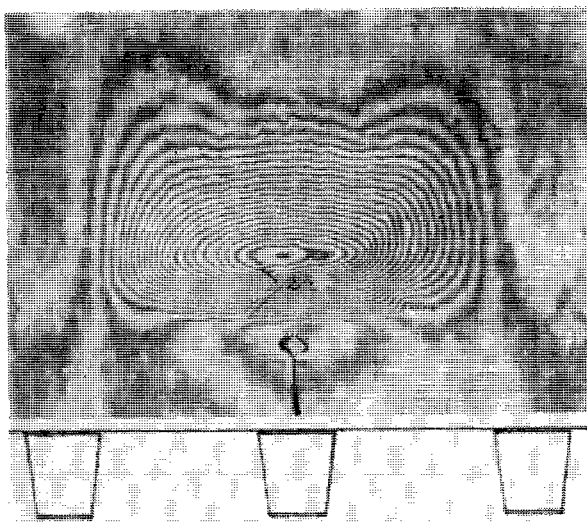
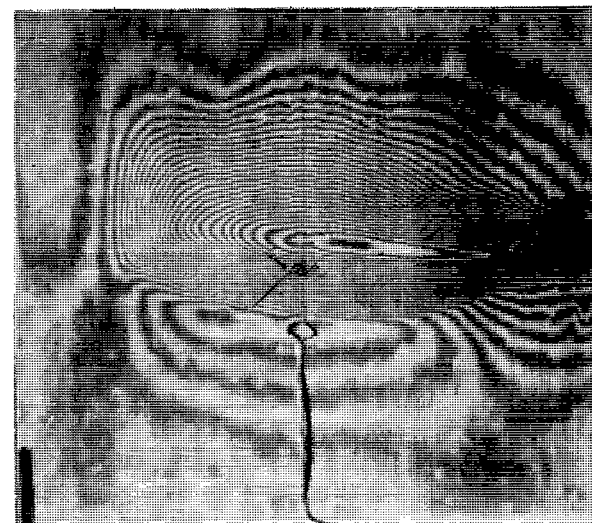
Figure 11.- Panel B7 (after impact in high-axial-stiffness region while at applied strain of 0.0030) before and after failure.

Several photographs of the moiré-fringe pattern taken during the residual strength test of panel B7 are shown in figure 11 along with a photograph of the failed panel. The moiré-fringe pattern shows considerable lateral deformation of the panel center, which may be due to impact-induced delamination or skin buckling. When the panel was damaged by impact, a reduction in applied load of 28.9 kN was measured. The 28.9-kN load reduction approximately corresponds to the load which the high-axial-stiffness region beneath the center stiffener is calculated to carry for an imposed strain of 0.0030. The panel failed at an applied strain of 0.0046 which is 58 percent of the design value.

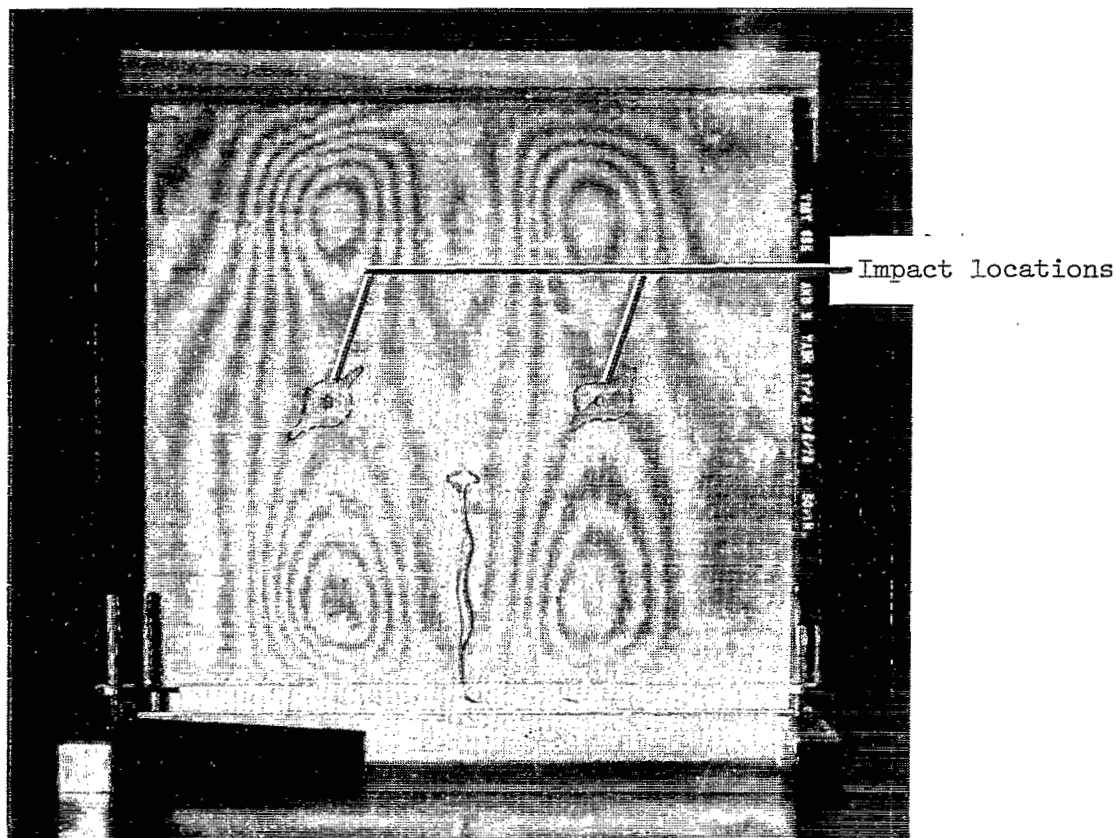
Figure 13.- Photograph of moiré-fringe pattern for panel B9 at applied axial strain of 0.0062 with impact damage at two locations in low-axial-stiffness region.

Impact damage in the low-axial-stiffness region.- In order to evaluate the effect of damage in the angle-ply, low-axial-stiffness region, panel B9 was damaged by impact in the skin region between stiffeners ( $\pm 45^\circ$  for the design B panels). The panel was loaded to an applied axial strain of 0.0040 when impact occurred. (See table II.) No reduction in the applied load upon impact was observed and no increase in axial strain was noted in the gage near the point of impact. Although some local fiber failure and delamination was observed, the failure did not propagate. After impact the panel was loaded to an applied strain of 0.0054 without propagation of local damage. At this load the panel was damaged in the remaining  $\pm 45^\circ$  skin region between stiffeners. (See table II.) No loss in load nor increase in strain near the point of impact was detected. This panel was subsequently loaded to an applied strain of 0.0062 at which a moiré-fringe pattern was observed in the end regions (see fig. 13) similar to that observed for the undamaged test panel. A local fringe pattern can be seen in the figure at each impact location.

Following this test the panel was inspected ultrasonically to evaluate the extent of the damaged region. The subsurface-damage region is outlined on the panel in figure 13. The two damaged regions are about the same size, which indicates that the magnitude of the applied strain had no apparent effect on the extent of local damage. These results indicate that impact damage in the regions having high axial stiffness is significantly more detrimental than it is in regions of low axial stiffness.
